## Sample Work; Water Resources Commissioner, Muskegon County

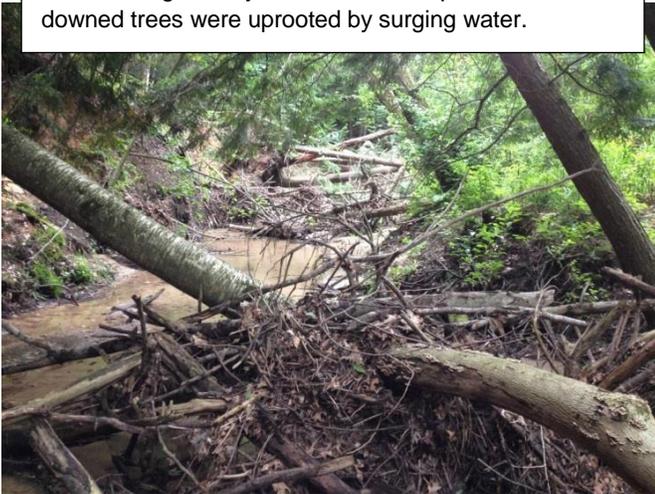
Sta 135 Pierson Drain **before**: a flashy system deposited so much sediment in the stream it became very wide and shallow. This creek can't move water well or support most aquatic life. A flashy system means runoff enters it fast; water levels rise quickly, churn through the system and tear it up. Most of the downed trees were uprooted by surging water.

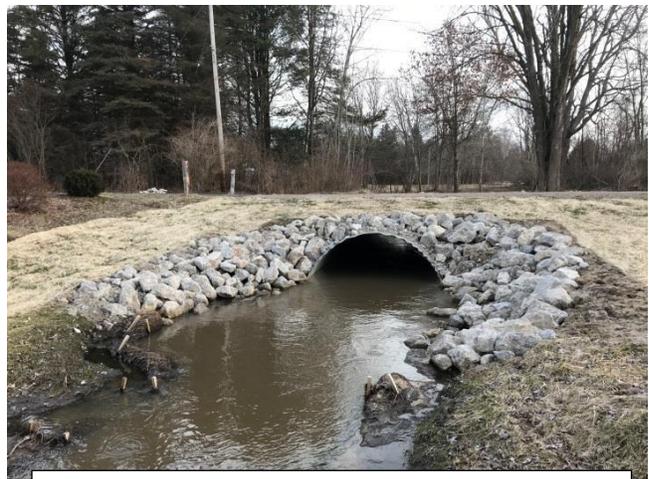
Sta. 63 Furman Drain; **before**. Twin culverts do not pass water effectively. Note the culvert on the left is nearly closed off. This can back-up water and cause scouring damage on the other side of the culvert.

Sta. 63 Furman Drain; **after**. A larger single culvert passes water more effectively. The rock rip rap prevents erosion and scouring damage around the culvert and roadway. Note; scouring is the act of water eating away the soil along stream banks. When this soil settles out of the water column it is called sediment, which clogs the drainage system and smothers aquatic life.

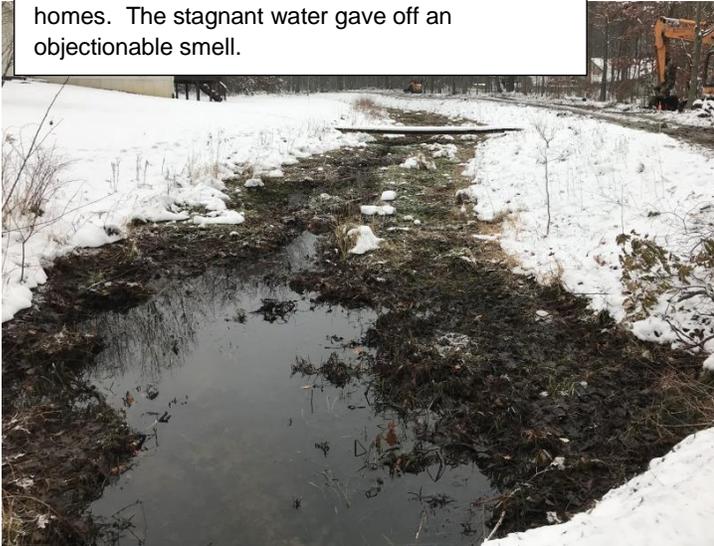
Sta 158 Kuis Drain **before**: stream channel choked with vegetation and sediment behind homes. The stagnant water gave off an objectionable smell.

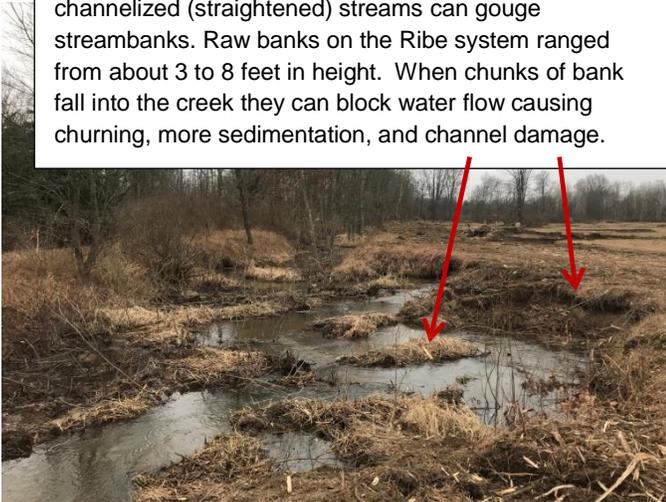
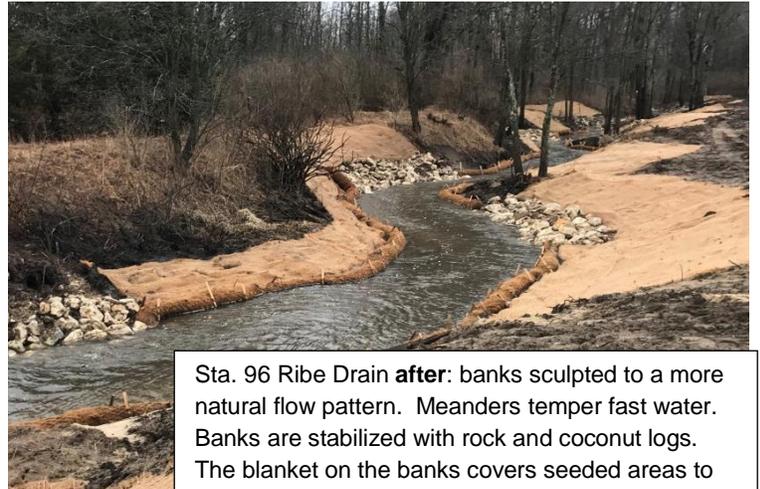
Sta. 96 Ribe Drain **before**: surging water from channelized (straightened) streams can gouge streambanks. Raw banks on the Ribe system ranged from about 3 to 8 feet in height. When chunks of bank fall into the creek they can block water flow causing churning, more sedimentation, and channel damage.
