# Dam Safety Inspection Report

## Little Black Lake Dam

## Michigan Dam ID #1687 A Low Hazard Potential Structure

Inspected on July 25, 2017

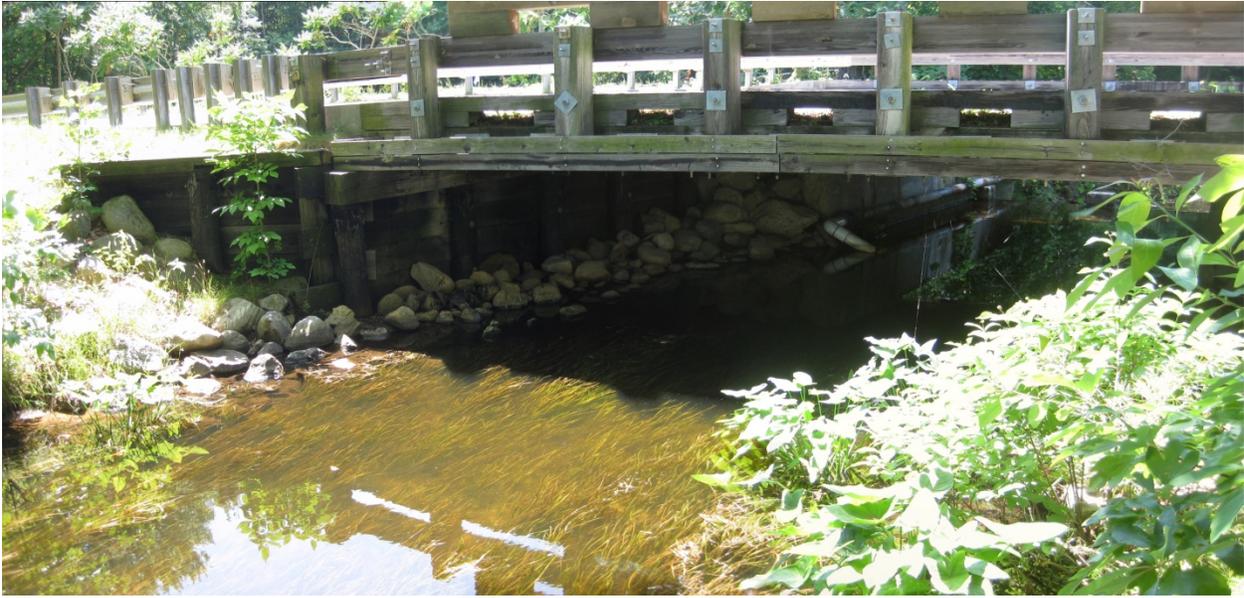
Little black Creek looking downstream

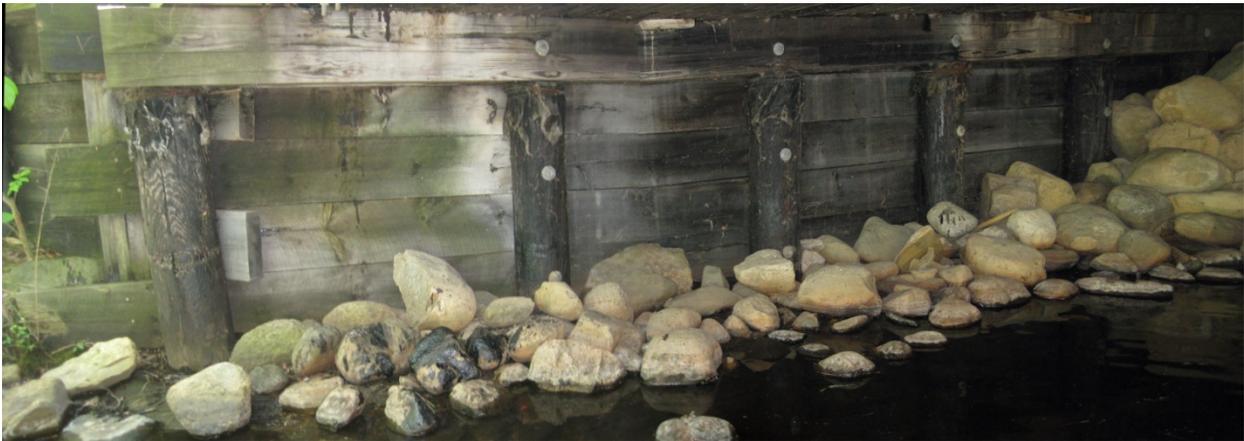
Riprap bank protection on southeast side of bridge structure

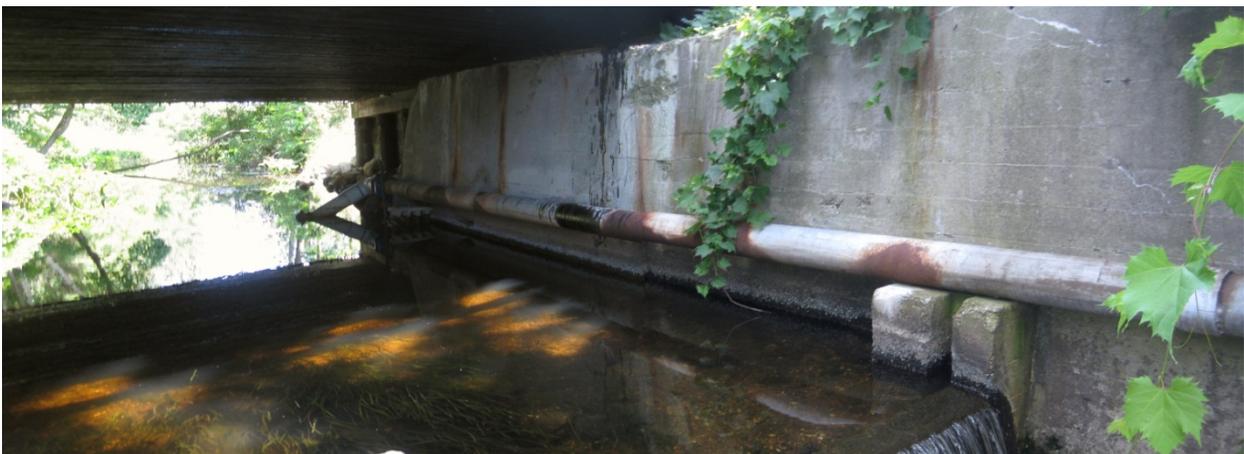
No deficiencies are present at the Little Black Lake Dam that could lead to the failure of the dam at this time. The presence of an irrigation pipeline for an adjacent golf course slightly reduces the conveyance capacity of this structure. However, sufficient spillway capacity is presently available, making this pipe's presence unimportant.

Golf Course irrigation pipe, looking upstream

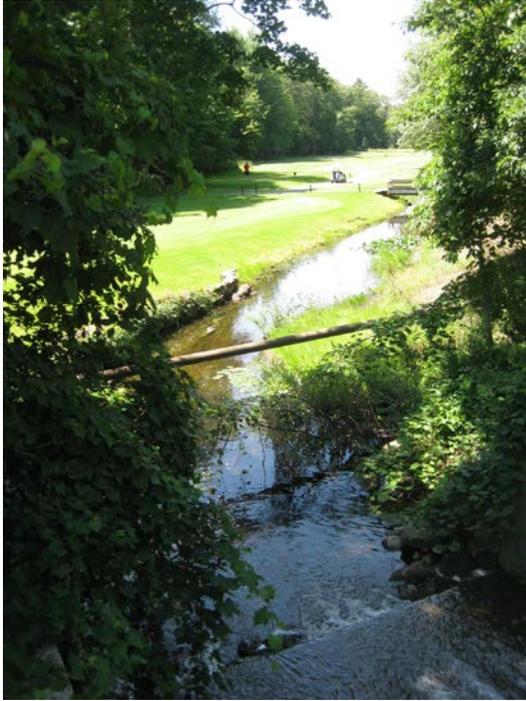
Little Black Creek outlet channel looking downstream (west)

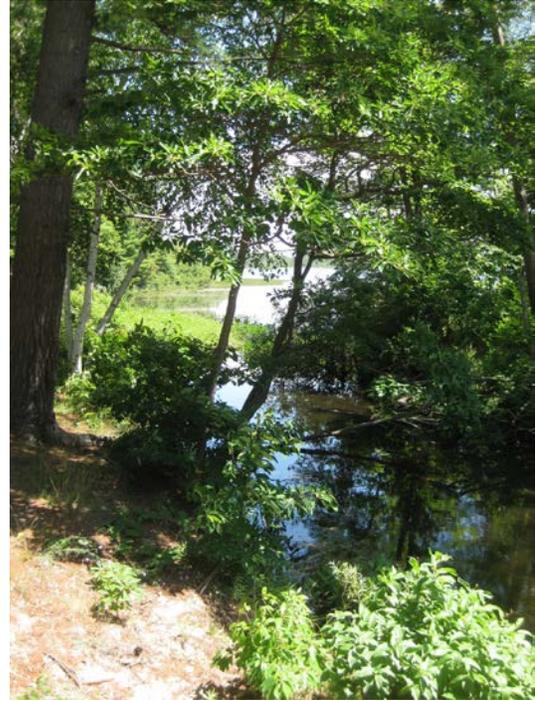
Little Black Creek inlet channel looking upstream (east)

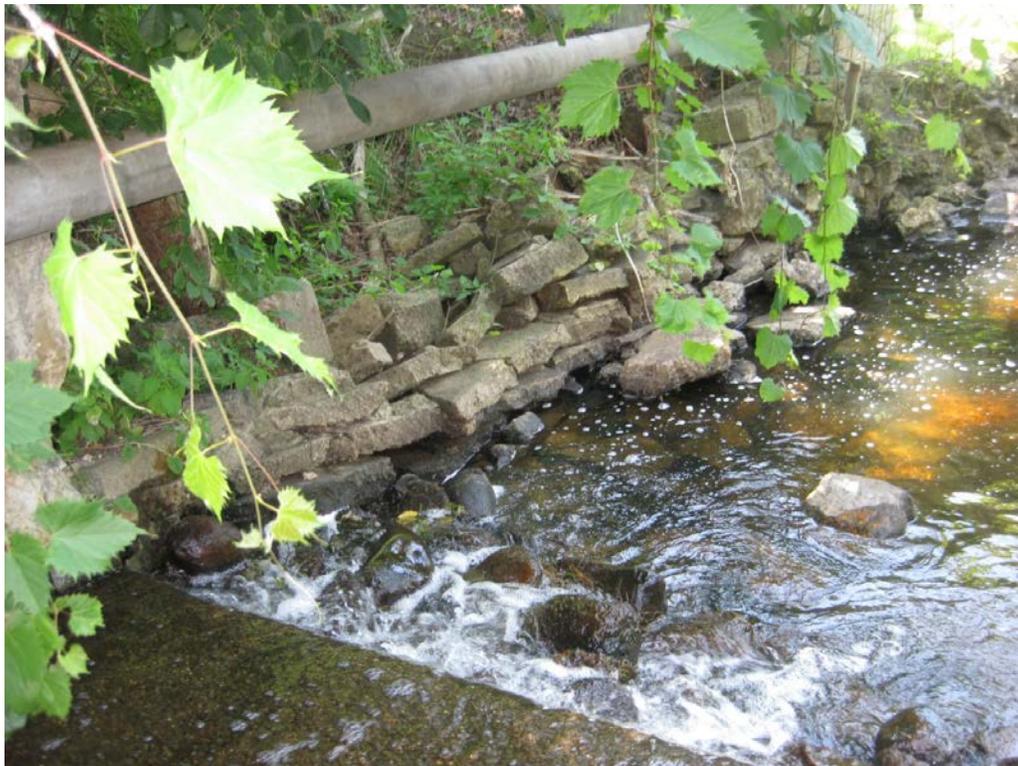
Broken concrete bank protection (typ.)

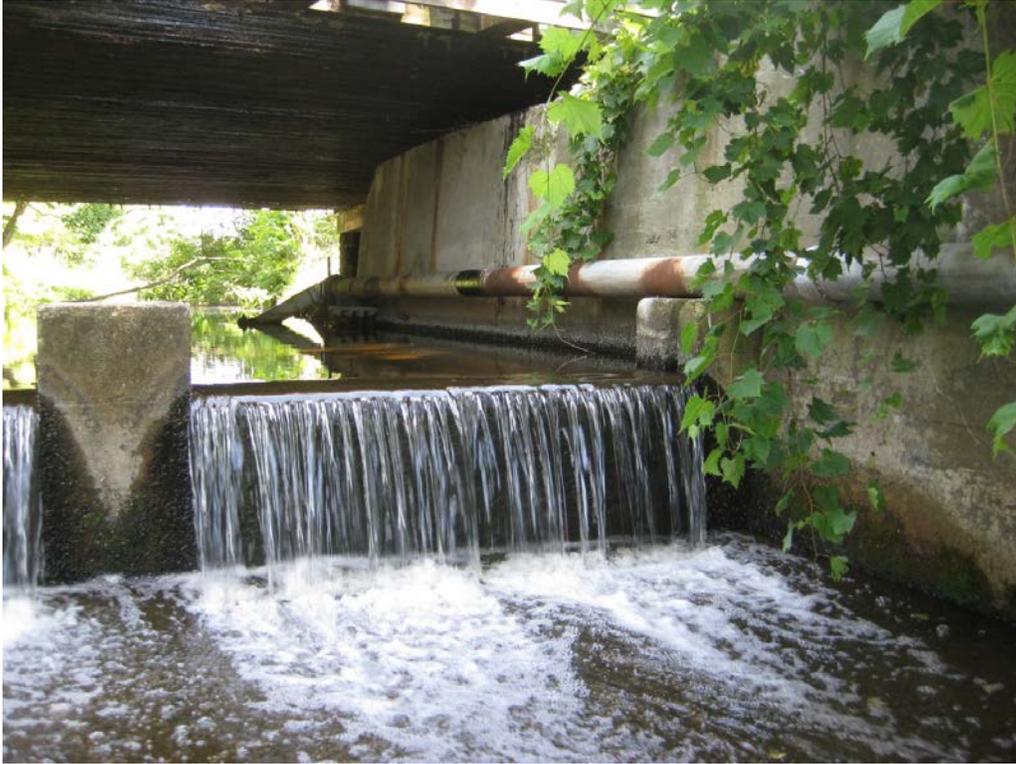
South side of weir structure looking upstream

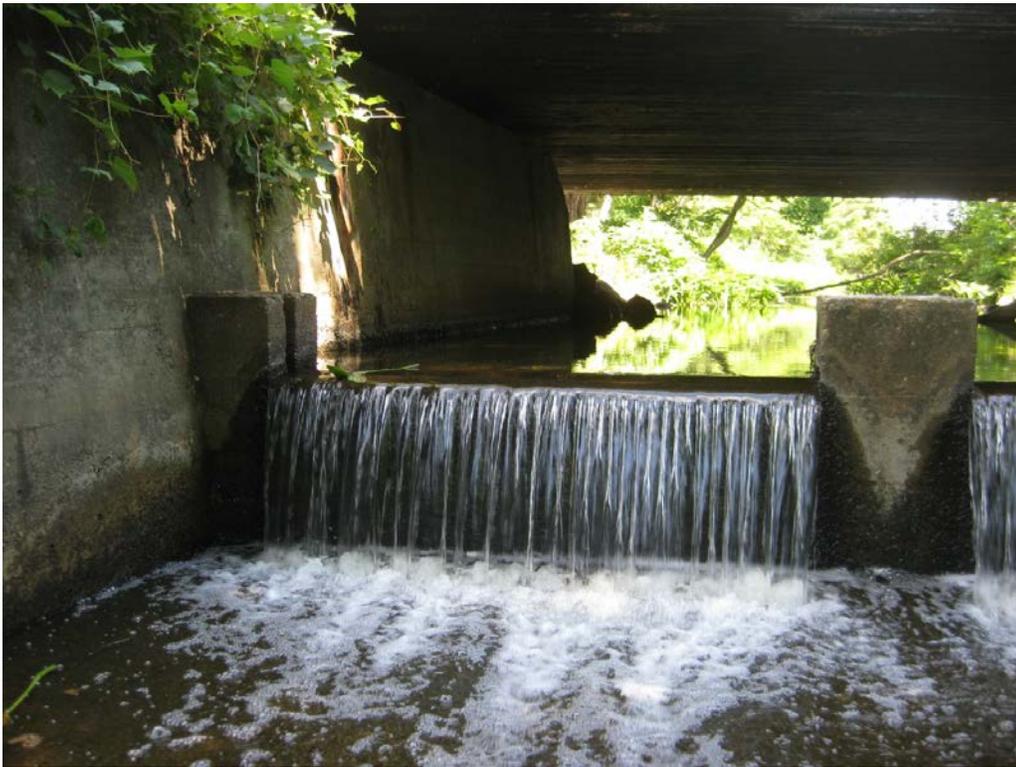
North side of weir structure looking upstream

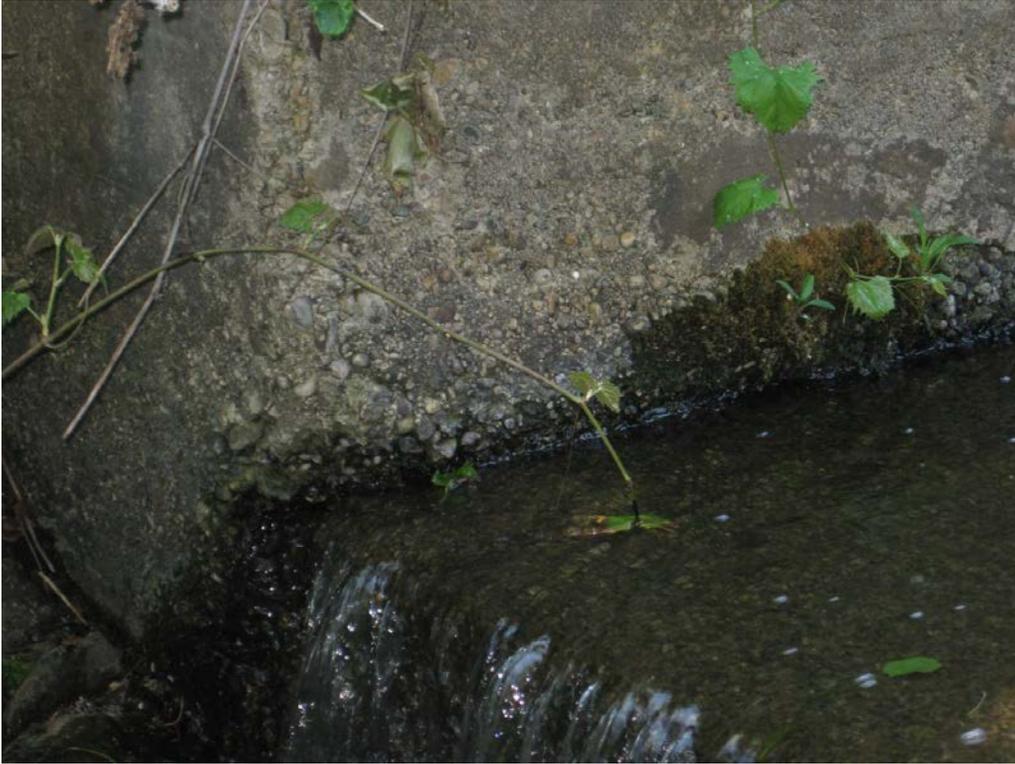
The only deficiency noticed during this inspection cycle is the continued deterioration of concrete members via spalling and cleaving, as shown on enclosed photographs. Future inspections should focus on the progression of concrete spalling and make note when it erodes to the point of jeopardizing structural stability.

Minor spalling of concrete on northwest wingwall

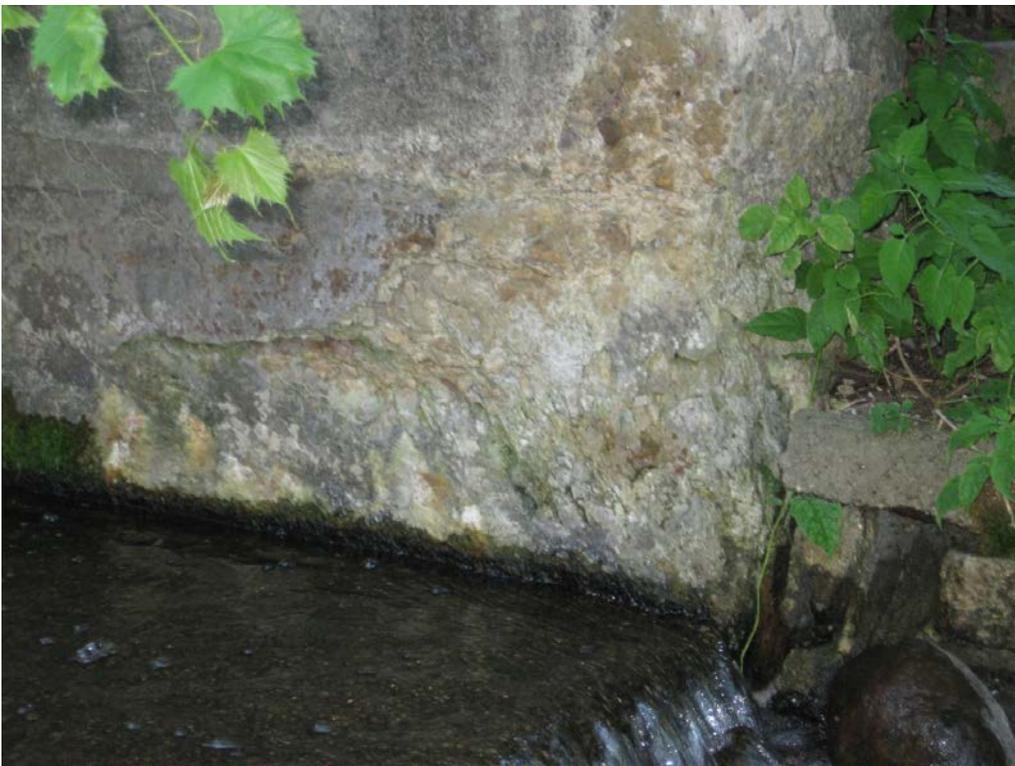
Moderate spalling of concrete on southwest wingwall

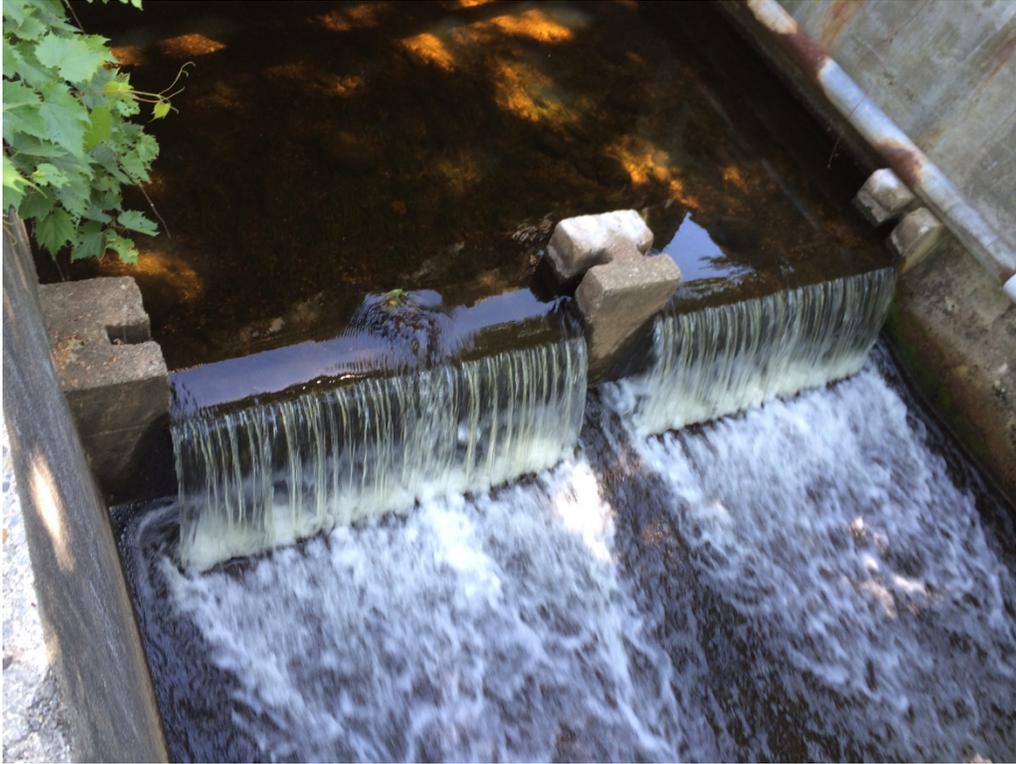
Outlet structure - slotted piers for stoplogs (prior photograph)

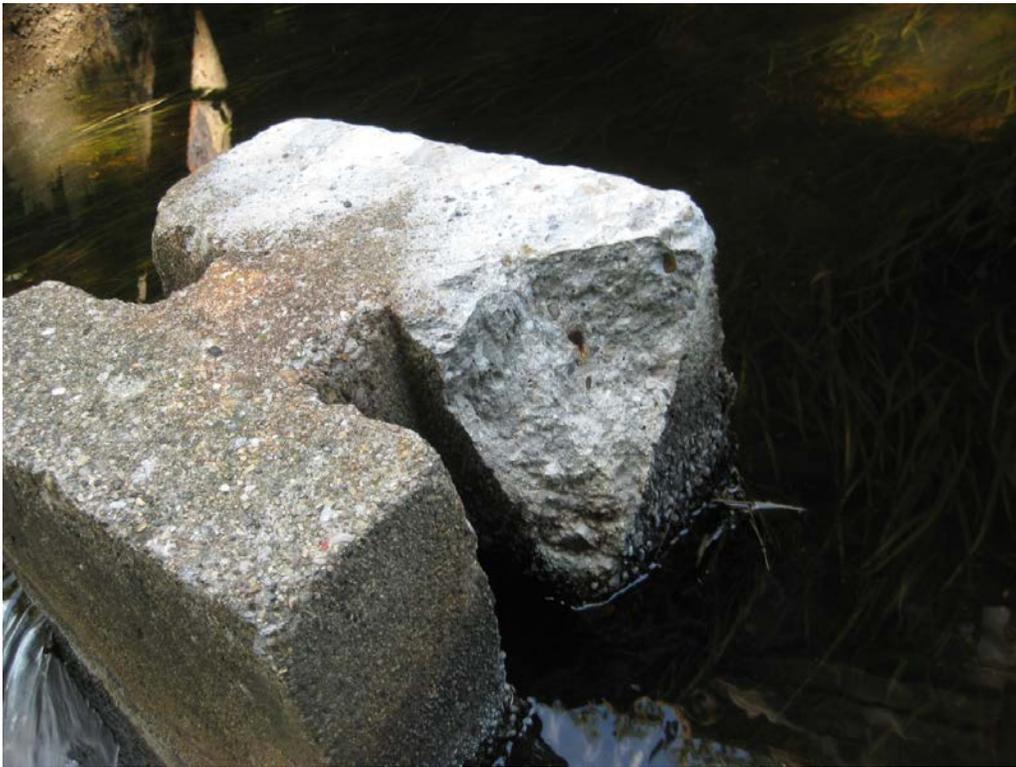
Damaged concrete on slotted pier

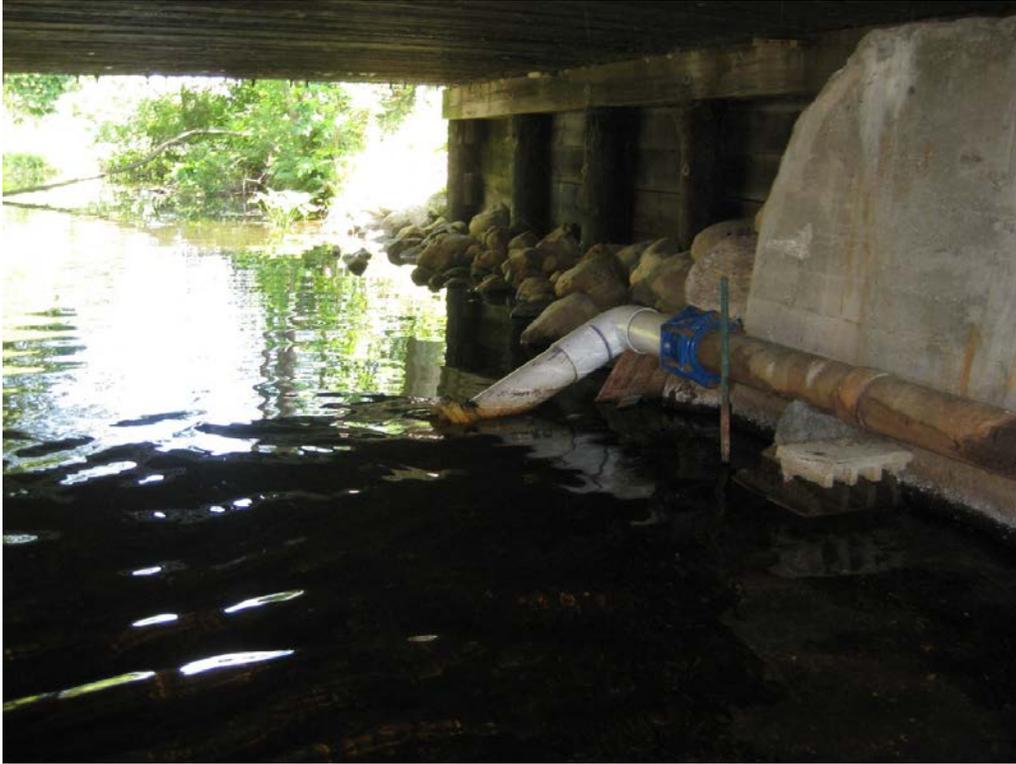
Golf course irrigation inlet pipe

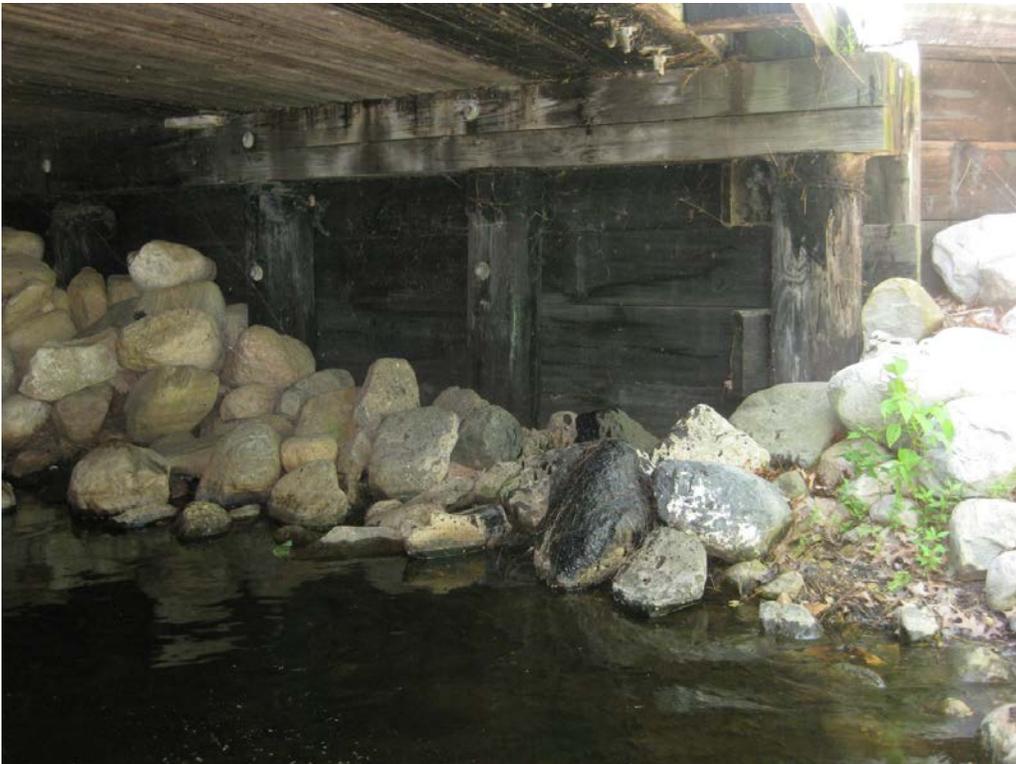
Riprap bank protection on northeast side of bridge structure

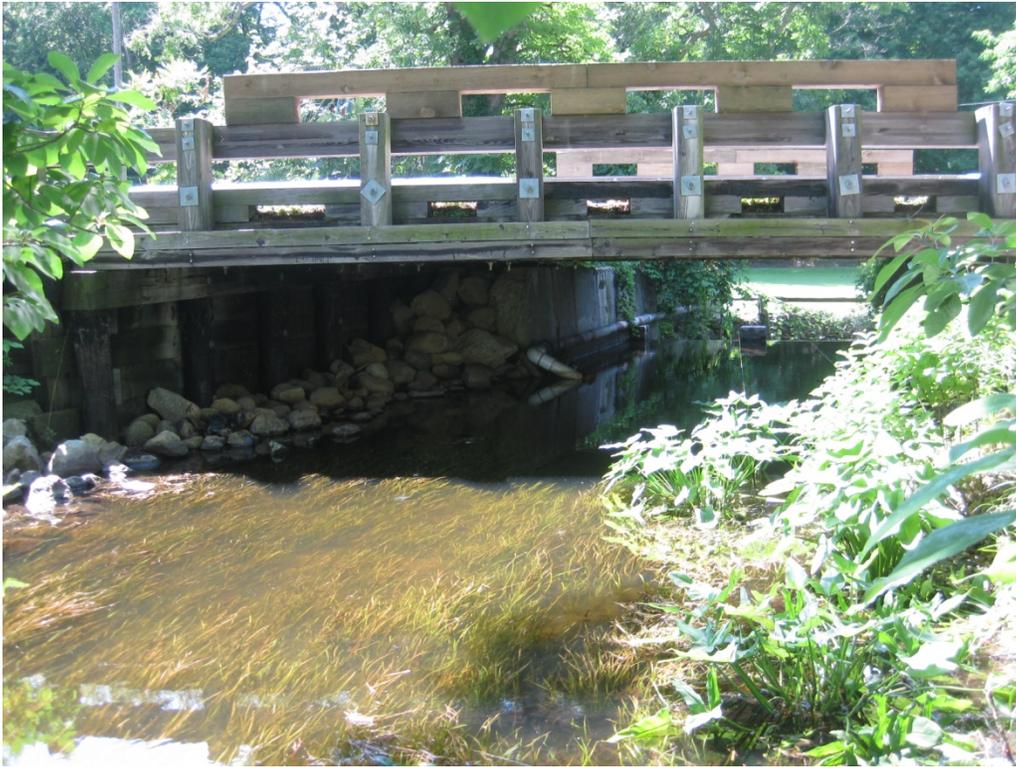
Little Black Creek looking downstream (west)

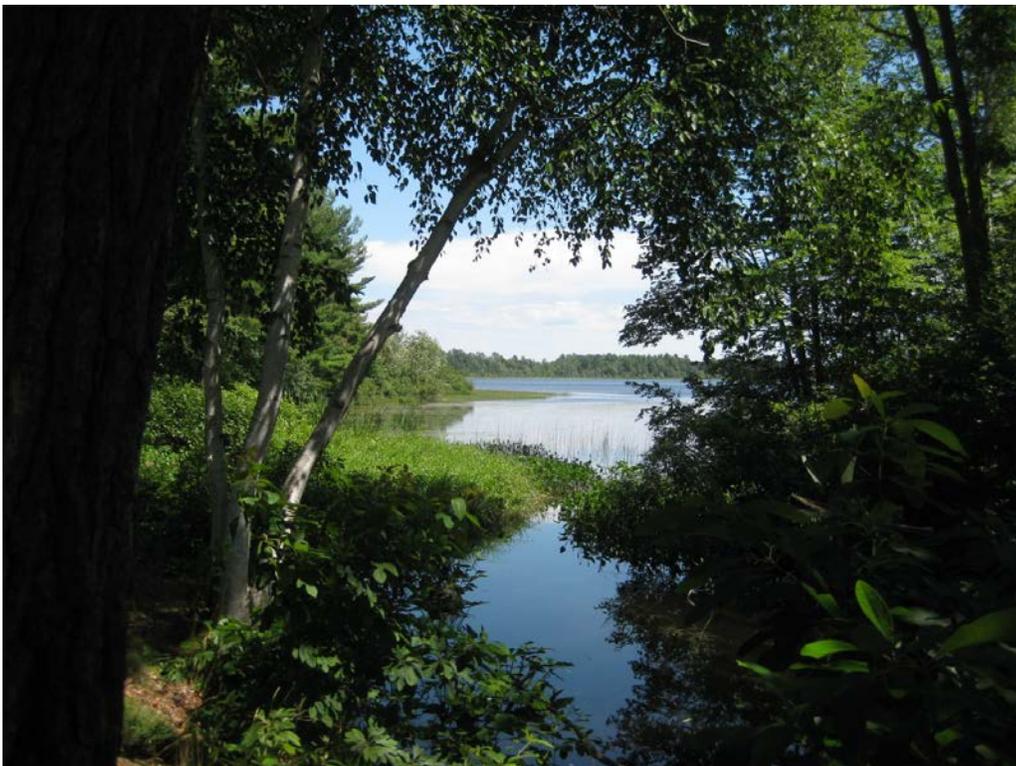
Looking upstream (east) toward Little Black Lake
